**WETLAND INVESTIGATION
CITY OF LAKE ELMO
FORMER 3M PARCEL**

**PORTION OF PARCEL 1602921240002
LAKE ELMO, WASHINGTON CO., MN**

**APRIL 16, 2021
AE JOB NO. 16349**

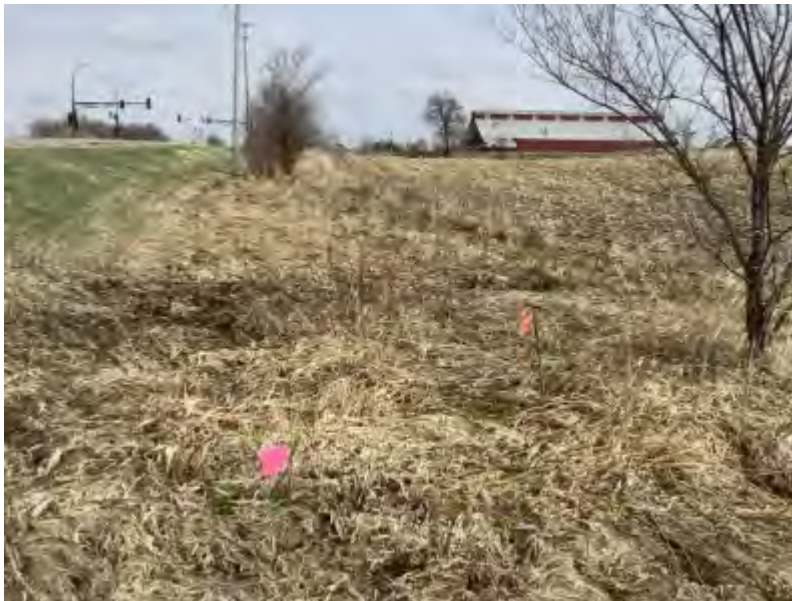
Viewing North / Abrupt Transition to Wetland Confined to Ditch

Wetland	RESOURCE TYPE
0.09-Acre(s)	TOTAL AREA WITHIN ECB
0.1-Acre(s)	TOTAL EST. AREA
Seasonally Flooded Basin	EGGERS & REED
Type 1	CIRCULAR 39
PEM1A	COWARDIN
Manage 2	MnRAM ²
DOMINANT HYDROPHYTIC VEGETATION	
<i>Alnus incana</i>	Gray alder
<i>Phalaris arundinacea</i>	Reed canary grass
<i>Typha x glauca</i>	Hybrid cattail
HYDRIC SOIL INDICATORS	
Redox Dark Surface	F6
WETLAND HYDROLOGY DETERMINATION	
Surface Water	A1
Saturation	A3
Drainage Patterns	B10
Geomorphic Position	D2
FAC-Neutral Test	D5

RATIONALE FOR DETERMINATION	The wetland occupies a ditch and the delineated edge is topography driven. The transition to upland is gradual and was determined based on a lack of hydrology and hydrophytic plant community (Appendix A, Figure 5).
ASSOCIATED RESOURCES	Resource is not directly hydrologically connected to an adjacent resource.
ATYPICAL/PROBLEMATIC CONDITIONS	Review of antecedent precipitation on this day was normal and field conditions were adequate for reasonable vegetation and hydrology determinations.
CONSISTENCY WITH DESKTOP REVIEW	Wetland was delineated within non-hydric soil map unit; however, hydric soils are present. Field delineation identified a type 1 wetland not identified by NWI.
POST-TEP REVIEW ADJUSTMENT	N/A

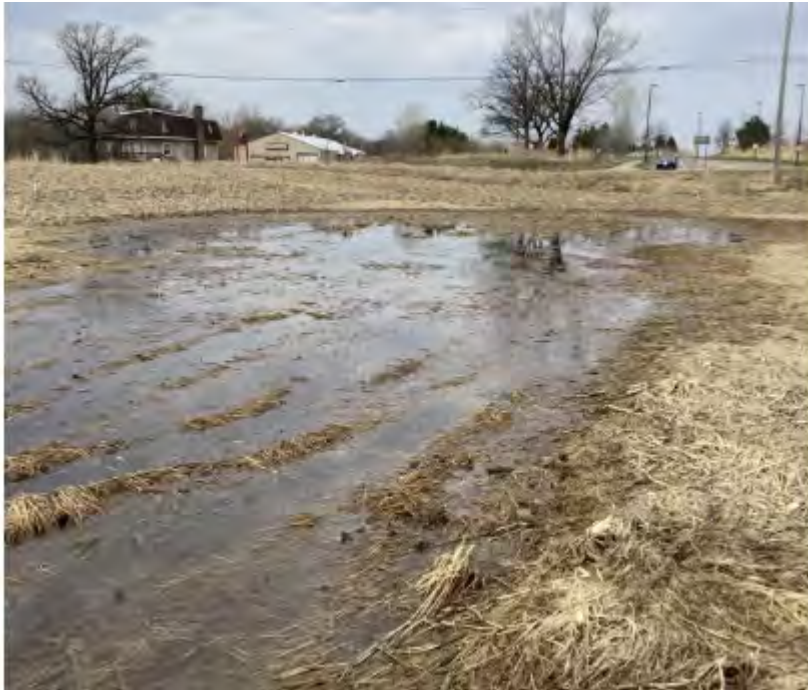
Viewing West / Gradual Transition to Wetland

Wetland	RESOURCE TYPE
0.45-Acre(s)	TOTAL AREA WITHIN ECB
0.45-Acre(s)	TOTAL EST. AREA
Seasonally Flooded Basin	EGGERS & REED
Type 1	CIRCULAR 39
PEM1Af	COWARDIN
Manage 2	MnRAM ²
DOMINANT HYDROPHYTIC VEGETATION	
<i>Panicum capillare</i>	Witch grass
<i>Nasturtium officinale</i>	Watercress
HYDRIC SOIL INDICATORS	
Best Professional Judgement	BPJ
WETLAND HYDROLOGY DETERMINATION	
Surface Water	A1
High Water Table	A2
Saturation	A3
Aerial Saturation Visible	C9
Geomorphic Position	D2
FAC-Neutral Test	D5

RATIONALE FOR DETERMINATION	The wetland occupies low landscape position within a farmed area and the delineated edge is topography driven. The transition to upland is gradual and was determined based on a lack of hydric soil profile and hydrology (Appendix A, Figure 5).
ASSOCIATED RESOURCES	Resource is not directly hydrologically connected to an adjacent resource.
ATYPICAL/PROBLEMATIC CONDITIONS	Farmed area and normal circumstances are not present. Review of antecedent precipitation on this day was normal and field conditions were adequate for reasonable vegetation and hydrology determinations.
CONSISTENCY WITH DESKTOP REVIEW	Wetland was delineated within predominantly non-hydric soil map unit; however, hydric soils were observed. Field delineation identified a type 1 wetland not noted by NWI.
POST-TEP REVIEW ADJUSTMENT	N/A

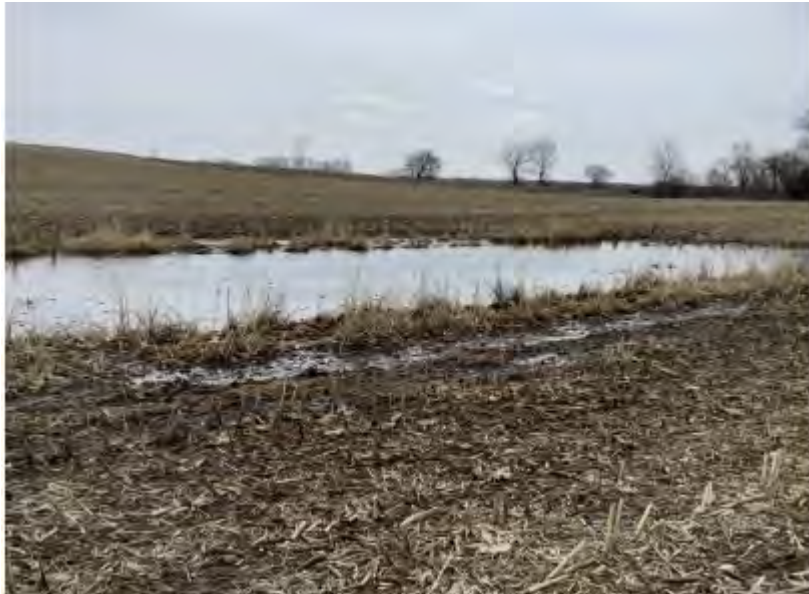
Viewing North / Gradual Transition to Wetland

Wetland	RESOURCE TYPE
0.16-Acre(s)	TOTAL AREA WITHIN ECB
0.16-Acre(s)	TOTAL EST. AREA
Seasonally Flooded Basin	EGGERS & REED
Type 1	CIRCULAR 39
PEM1Af	COWARDIN
Manage 2	MnRAM ²
DOMINANT HYDROPHYTIC VEGETATION	
<i>Panicum capillare</i>	Witch grass
<i>Phragmites australis</i>	Common reed
HYDRIC SOIL INDICATORS	
Redox Dark Surface	F6
WETLAND HYDROLOGY DETERMINATION	
Surface Water	A1
High Water Table	A2
Saturation	A3
Aerial Saturation Visible	C9
Geomorphic Position	D2
FAC-Neutral Test	D5

RATIONALE FOR DETERMINATION	The wetland occupies low landscape position and the delineated edge is topography driven. The transition to upland is gradual and was determined based on a lack of hydrology, hydrophytic plant community, and hydric soil profile (Appendix A, Figure 5).
ASSOCIATED RESOURCES	Resource is not directly hydrologically connected to an adjacent resource.
ATYPICAL/PROBLEMATIC CONDITIONS	Area is within a farmed field and normal circumstances are not present. Review of antecedent precipitation on this day was normal and field conditions were adequate for reasonable vegetation and hydrology determinations.
CONSISTENCY WITH DESKTOP REVIEW	Wetland was delineated within predominantly non-hydric soil map unit; however, hydric soils were observed. Field delineation identified a type 1 wetland not noted by NWI.
POST-TEP REVIEW ADJUSTMENT	N/A

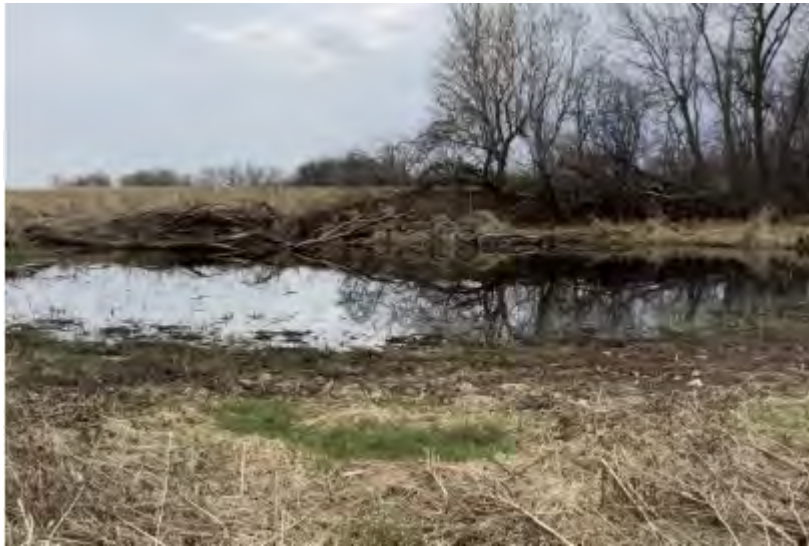
Viewing East / Gradual Transition to Wetland

Wetland	RESOURCE TYPE
0.33-Acre(s)	TOTAL AREA WITHIN ECB
0.33-Acre(s)	TOTAL EST. AREA
Fresh Wet Meadow	EGGERS & REED
Type 2	CIRCULAR 39
PEM1B	COWARDIN
Manage 2	MnRAM ²
DOMINANT HYDROPHYTIC VEGETATION	
<i>Panicum capillare</i>	Witch grass
<i>Phalaris arundinacea</i>	Reed canary grass
<i>Nasturtium officinale</i>	Watercress
HYDRIC SOIL INDICATORS	
Redox Dark Surface	F6
WETLAND HYDROLOGY DETERMINATION	
High Water Table	A2
Saturation	A3
Aerial Saturation Visible	C9
Geomorphic Position	D2
FAC-Neutral Test	D5

RATIONALE FOR DETERMINATION	The wetland occupies low landscape position and the delineated edge is topography driven. The transition to upland is gradual and was determined based on a lack of hydrology (Appendix A, Figure 5).
ASSOCIATED RESOURCES	Resource is not directly hydrologically connected to an adjacent resource.
ATYPICAL/PROBLEMATIC CONDITIONS	Review of antecedent precipitation on this day was normal and field conditions were adequate for reasonable vegetation and hydrology determinations. 2021 growing season marked by presence of emergence of reed canary grass and other species within the basin and elsewhere.
CONSISTENCY WITH DESKTOP REVIEW	Wetland was delineated within predominantly non-hydric soil map unit; however, hydric soils were observed. Field delineation identified a type 2 wetland not noted by NWI. VBWD MnRAM assessment mapped this resource as Manage 1; however, low habitat quality and isolated landscape position resulted in a determination of Manage 2.

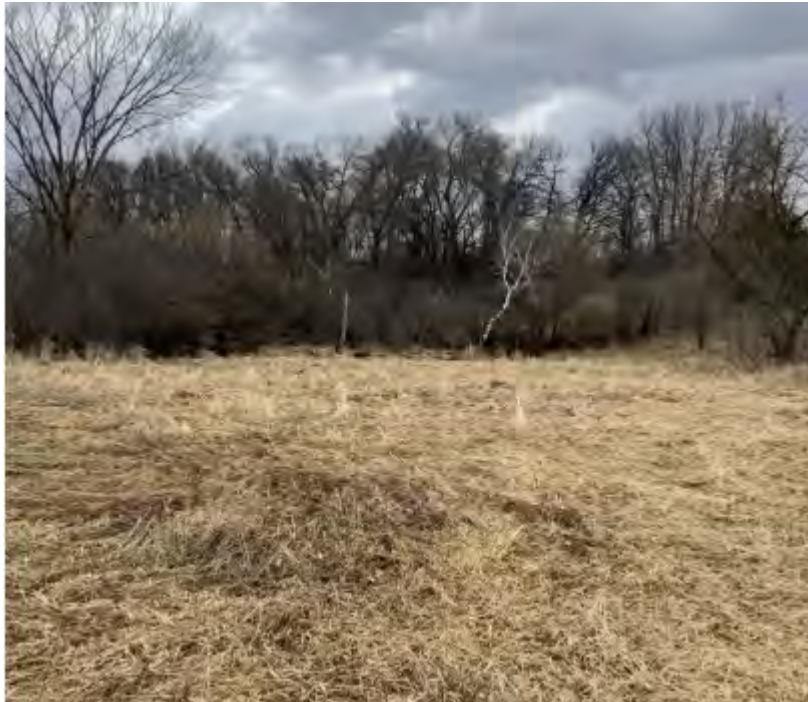
Viewing North / Gradual Transition to Wetland

Wetland	RESOURCE TYPE
0.46-Acre(s)	TOTAL AREA WITHIN ECB
0.46-Acre(s)	TOTAL EST. AREA
Fresh Wet Meadow	EGGERS & REED
Type 2	CIRCULAR 39
PEM1B	COWARDIN
Manage 2	MnRAM ²
DOMINANT HYDROPHYTIC VEGETATION	
<i>Phalaris arundinacea</i>	Reed canary grass
HYDRIC SOIL INDICATORS	
Thick Dark Surface	A12
WETLAND HYDROLOGY DETERMINATION	
High Water Table	A2
Saturation	A3
Geomorphic Position	D2
FAC-Neutral Test	D5

RATIONALE FOR DETERMINATION	The wetland occupies a sloped landscape position and the delineated edge is topography- and watershed catchment-driven. The transition to upland is gradual and was determined based on a lack of hydrophytic plant community and hydric soil profile (Appendix A, Figure 5).
ASSOCIATED RESOURCES	Resource is not directly hydrologically connected to an adjacent resource.
ATYPICAL/PROBLEMATIC CONDITIONS	Review of antecedent precipitation on this day was normal and field conditions were adequate for reasonable vegetation and hydrology determinations. 2021 growing season marked by presence of emergence of reed canary grass and other species within the basin and elsewhere.
CONSISTENCY WITH DESKTOP REVIEW	Wetland was delineated within predominantly hydric soil map unit and soil investigation confirmed status. Field delineation identified a type 2 wetland not noted by NWI.
POST-TEP REVIEW ADJUSTMENT	N/A

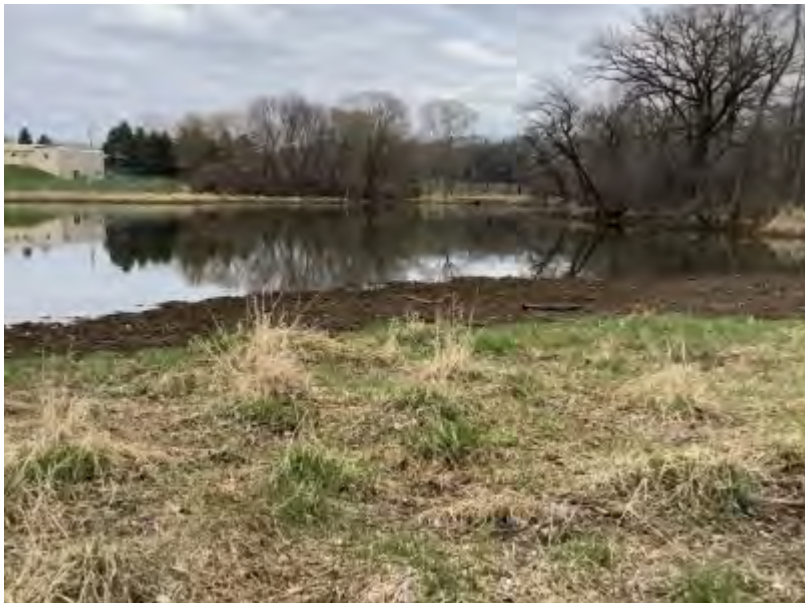
Viewing Northwest / Gradual Transition to Wetland

Wetland	RESOURCE TYPE
0.82-Acre(s)	TOTAL AREA WITHIN ECB
5.09-Acre(s)	TOTAL EST. AREA
Fresh Wet Meadow/Open Water	EGGERS & REED
Type 2/5	CIRCULAR 39
PUBF/EM1B	COWARDIN
Preserve	MnRAM ²
DOMINANT HYDROPHYTIC VEGETATION	
<i>Phalaris arundinacea</i>	Reed canary grass
HYDRIC SOIL INDICATORS	
Best Professional Judgement	BPJ
WETLAND HYDROLOGY DETERMINATION	
Geomorphic Position	D2
FAC-Neutral Test	D5

RATIONALE FOR DETERMINATION	The wetland occupies low landscape position and the delineated edge is topography driven. The transition to upland is gradual and was determined based on a lack of hydrology (Appendix A, Figure 5).
ASSOCIATED RESOURCES	Resource extends offsite to the west.
ATYPICAL/PROBLEMATIC CONDITIONS	A pipeline right-of-way transects the area and soils were not investigated for safety reasons. Review of antecedent precipitation on this day was normal and field conditions were adequate for reasonable vegetation and hydrology determinations. 2021 growing season marked by presence of emergence of reed canary grass and other species within the basin and elsewhere.
CONSISTENCY WITH DESKTOP REVIEW	Wetland was delineated within predominantly hydric soil map unit and soil investigation confirmed status. Field delineation identified a type 2/5, which disagrees with type 1/3/5 noted by NWI. Type 1/3 wetland may be present offsite.

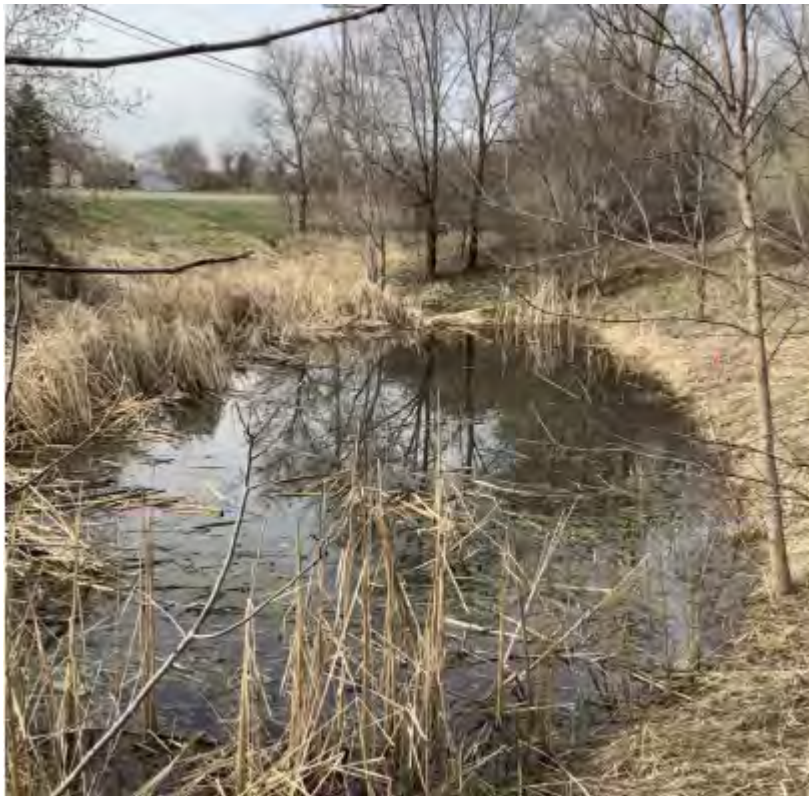
Viewing North / Abrupt Transition to Wetland

Wetland	RESOURCE TYPE
0.07-Acre(s)	TOTAL AREA WITHIN ECB
0.07-Acre(s)	TOTAL EST. AREA
Shallow Marsh/Open Water	EGGERS & REED
Type 3/5	CIRCULAR 39
PUBG/EM1Cx	COWARDIN
Manage 2	MnRAM ²
DOMINANT HYDROPHYTIC VEGETATION	
<i>Salix fragilis</i>	Crack willow
<i>Populus tremuloides</i>	Quaking aspen
<i>Alnus incana</i>	Speckled alder
<i>Phalaris arundinacea</i>	Reed canary grass
<i>Solidago canadensis</i>	Giant goldenrod
HYDRIC SOIL INDICATORS	
Redox Dark Surface	F6
WETLAND HYDROLOGY DETERMINATION	
High Water Table	A2
Saturation	A3
Water Stained Leaves	B9
Geomorphic Position	D2
FAC-Neutral Test	D5

RATIONALE FOR DETERMINATION	The wetland occupies low landscape position and the delineated edge is topography driven. The transition to upland is abrupt and was determined based on a lack of hydrology and hydric soil profile (Appendix A, Figure 5).
ASSOCIATED RESOURCES	Resource is not directly hydrologically connected to an adjacent resource.
ATYPICAL/PROBLEMATIC CONDITIONS	Review of antecedent precipitation on this day was normal and field conditions were adequate for reasonable vegetation and hydrology determinations. 2021 growing season marked by presence of emergence of reed canary grass and other species within the basin and elsewhere.
CONSISTENCY WITH DESKTOP REVIEW	Wetland was delineated within non-hydric soil map unit; however, hydric soils were observed. Field delineation identified a type 3/5 wetland and disagrees with Type 5 noted by NWI. Type 3 emergent vegetation was observed.
POST-TEP REVIEW ADJUSTMENT	N/A

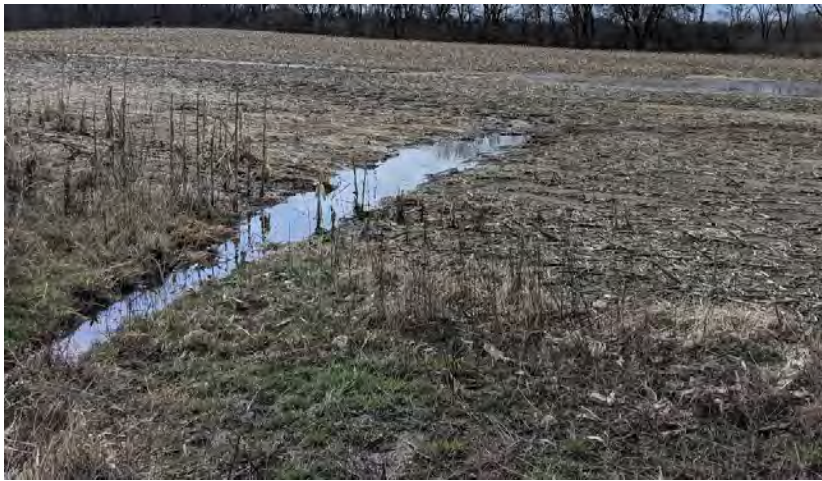
Viewing Northwest / Dry Land Flow Path

Dry Land RESOURCE TYPE	
DOMINANT VEGETATION	
None	
HYDRIC SOIL INDICATORS	
None	
WETLAND HYDROLOGY DETERMINATION	
Drainage patterns Aerial Saturation Visible	B10 C9

RATIONALE FOR DETERMINATION	Aerial photo review of the investigated area revealed sufficient wet signatures to warrant further investigation. Field review indicated that an absence of hydrophytic plant community and hydric soil profile. Based on this information it was determined that the area did not meet wetland criteria and was dryland (Appendix A, Figure 5).
ATYPICAL/PROBLEMATIC CONDITIONS	Review of antecedent precipitation on this day was normal and field conditions were adequate for reasonable vegetation and hydrology determinations.
CONSISTENCY WITH DESKTOP REVIEW	The soil survey and NWI desktop findings are consistent with on-site field conditions.
POST-TEP REVIEW ADJUSTMENT	N/A

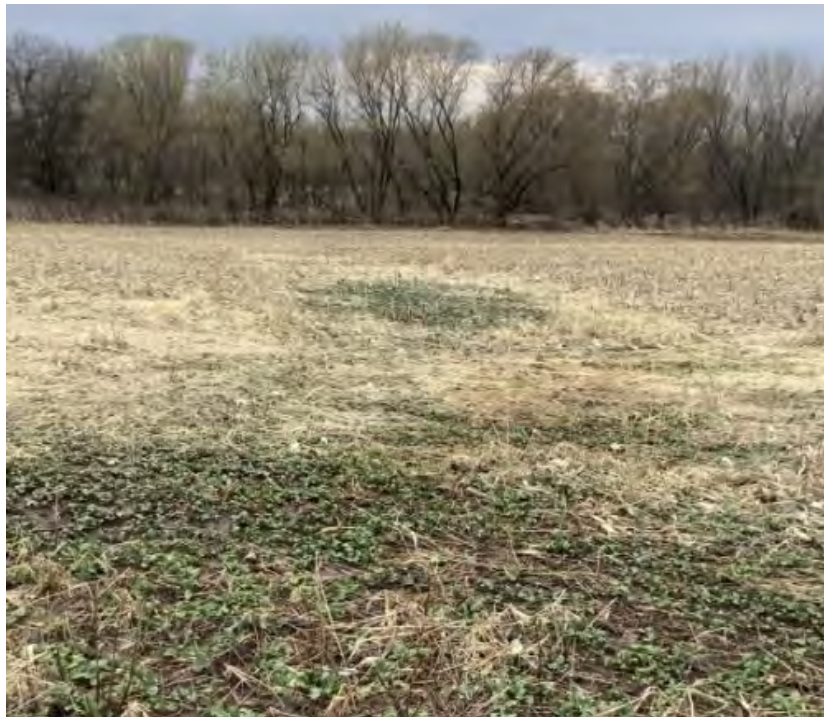
Viewing South / Dry Land Swale

Dry Land RESOURCE TYPE	
DOMINANT VEGETATION	
Acer negundo Arctium minus Setaria pumila	Box elder Common burdock Yellow foxtail
HYDRIC SOIL INDICATORS	
None	
WETLAND HYDROLOGY DETERMINATION	
Surface Water	A1
High Water Table	A2
Saturation	A3
Drainage patterns	B10
Aerial Saturation Visible	C8
Geomorphic Position	D2

RATIONALE FOR DETERMINATION	Aerial photo review of the investigated area revealed sufficient wet signatures to warrant further investigation. Field review indicated that an absence of hydrophytic plant community and hydric soil profile. Based on this information it was determined that the area did not meet wetland criteria and was dryland (Appendix A, Figure 5).
ATYPICAL/PROBLEMATIC CONDITIONS	The area is a farmed field and normal circumstances are not present. Review of antecedent precipitation on this day was normal and field conditions were adequate for reasonable vegetation and hydrology determinations. The 2021 growing season was active based on the emergence of common burdock.
CONSISTENCY WITH DESKTOP REVIEW	The soil survey and NWI desktop findings are consistent with on-site field conditions.
POST-TEP REVIEW ADJUSTMENT	N/A

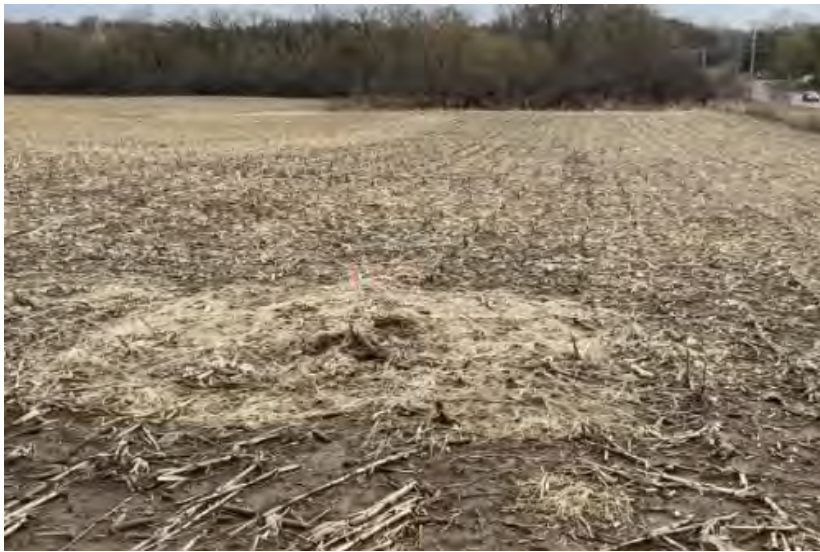
Viewing South / Dry Land Depression

Dry Land RESOURCE TYPE	
DOMINANT VEGETATION	
<i>Panicum capillare</i>	Witch grass
HYDRIC SOIL INDICATORS	
None	
WETLAND HYDROLOGY DETERMINATION	
Geomorphic Position	D2

RATIONALE FOR DETERMINATION	Aerial photo review of the investigated area revealed sufficient wet signatures to warrant further investigation. Field review indicated that an absence of hydric soil profile and wetland hydrology. Based on this information it was determined that the area did not meet wetland criteria and was dryland (Appendix A, Figure 5).
ATYPICAL/PROBLEMATIC CONDITIONS	The area is a farmed field and normal circumstances are not present. Review of antecedent precipitation on this day was normal and field conditions were adequate for reasonable vegetation and hydrology determinations.
CONSISTENCY WITH DESKTOP REVIEW	The soil survey and NWI desktop findings are consistent with on-site field conditions.
POST-TEP REVIEW ADJUSTMENT	N/A

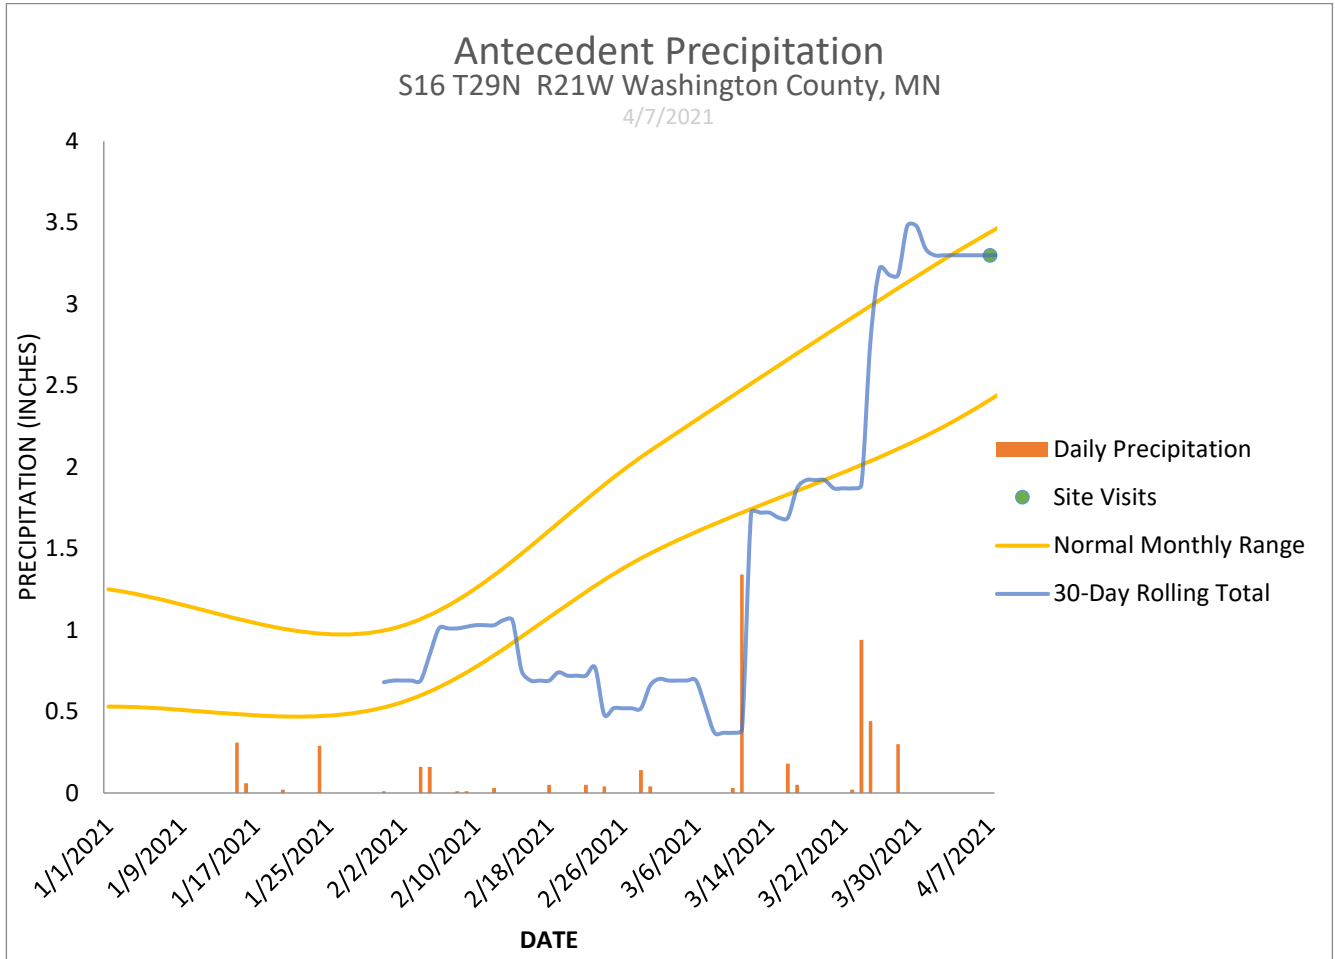
Appendix C, Figure 1. Graph of recent precipitation in comparison with the normal range of precipitation in the general site location. Daily precipitation data is plotted independently and as a 30-day rolling total up to the date of the site visit. The normal range is plotted from precipitation data recorded from 1981 to 2010. The normal range is represented in this graph with two lines, the 30th percentile and the 70th percentile of the period-of-record data distribution.

A review of the 30-day rolling precipitation data collected from the University of Minnesota Climatology Working Group (Appendix D) indicates that precipitation totals for the weeks prior to the site visit were within the range of average in the general project area. The overall hydrologic conditions were suitable for completing an accurate wetland determination and boundary delineation.

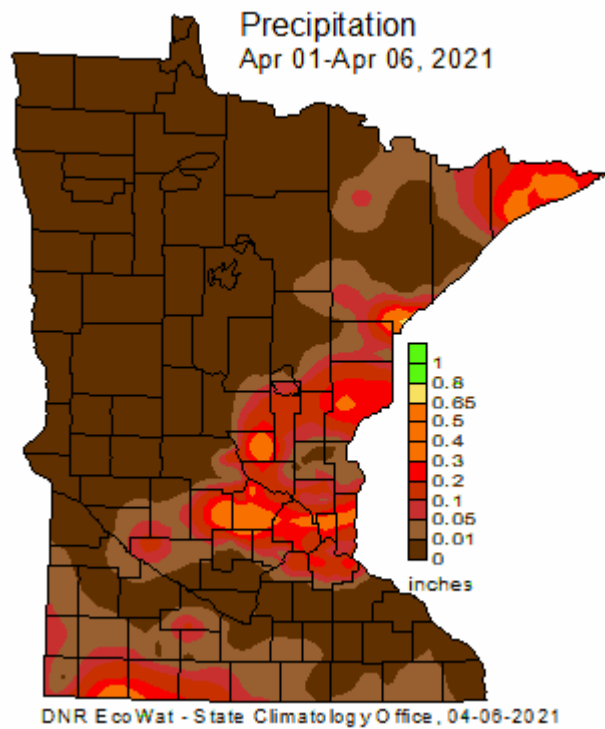
Appendix C, Figure 2. Minnesota State Climatology Office map depicting total precipitation for the week of the site visit.
